Condition & Maintenance Report

**Dell Quay Sailing Club
Dell Quay Road
Chichester
West Sussex
PO20 7EE**

Ref: MB/44601

Date: July 2019

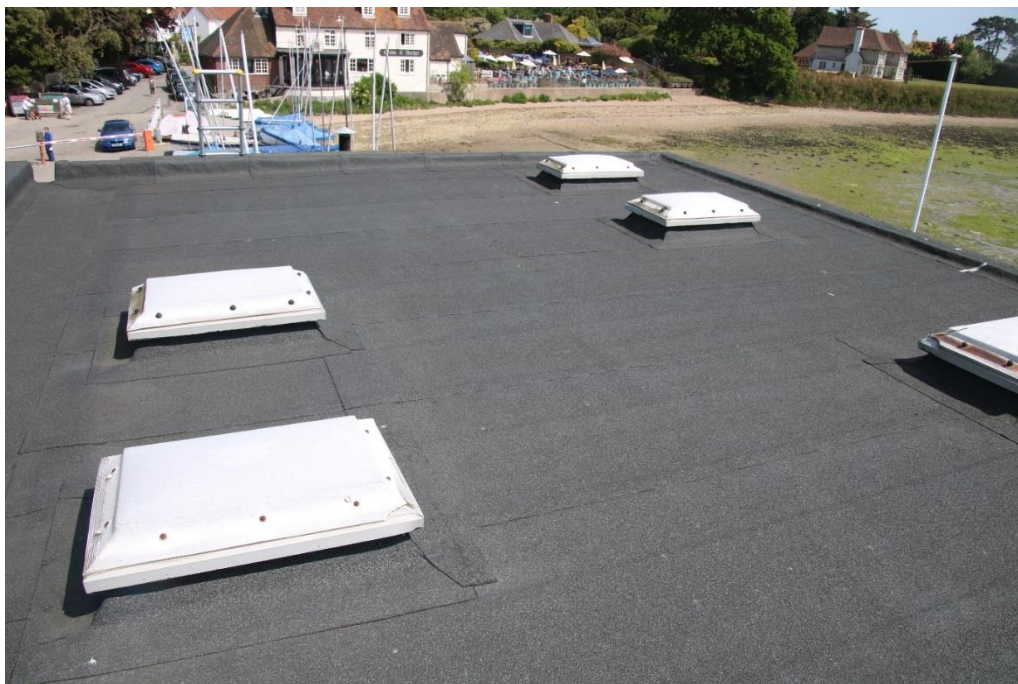
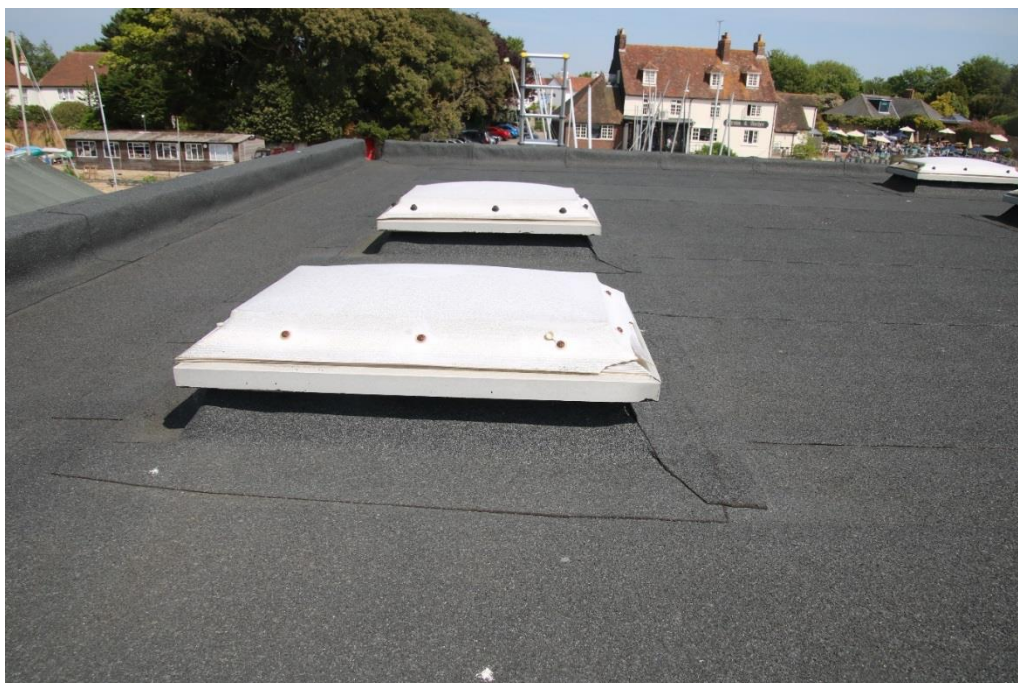
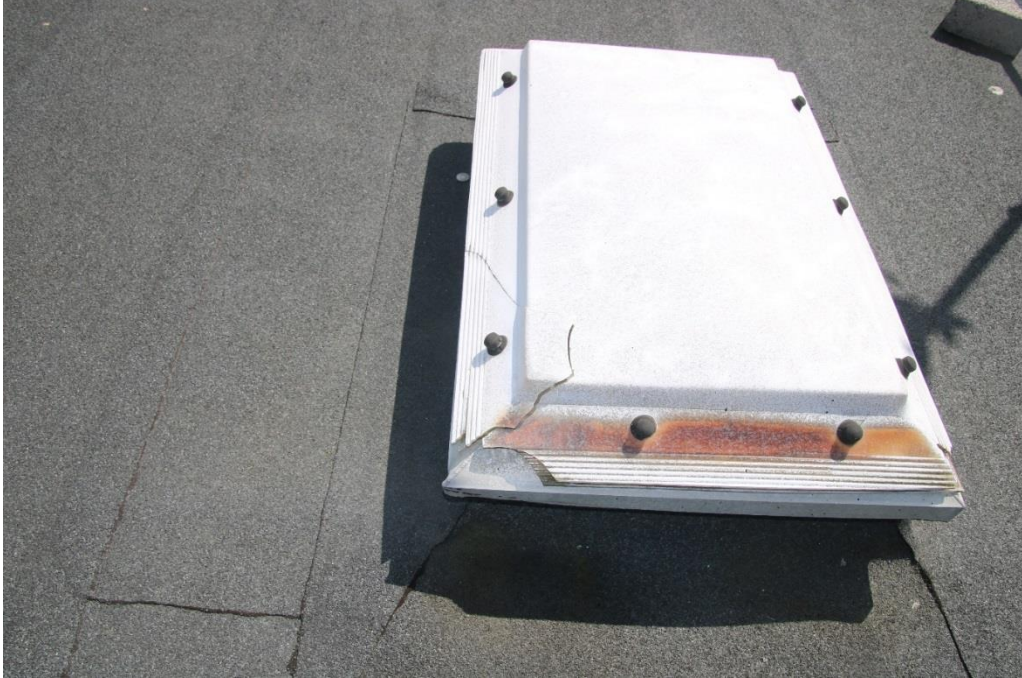
| Component | Location | Comment | Rating | Photo | Cost £ |
|--|---|--|---|---|---|
| External flat roof | Flat roof over changing rooms | <p>Flat roof with built-up felt roof covering. Incorporated within the flat roof are roof lights with curved tops.</p> <p>The edges of the roof have a built-up kerb detail and the flat roof covering is taken up over the parapet detail with a drip.</p> <p>In view of the age of the roof, further investigations were undertaken to determine the roof built up and the life expectancy of the current construction. This showed that the insulation levels were very poor which will lead to high heating costs. There were many major areas of ponding of this roof. Roof coverings of this type reinforced felt have a limited life expectancy and it is likely that full replacement of the flat roof covering will be required in the near future. When these works are carried out it is recommended that the opportunity should be taken to improve the insulation levels to the existing flat roof. A full report detailing the investigations accompanies this report.</p> | 2 | 1, 2 & 3 | 25,000 |

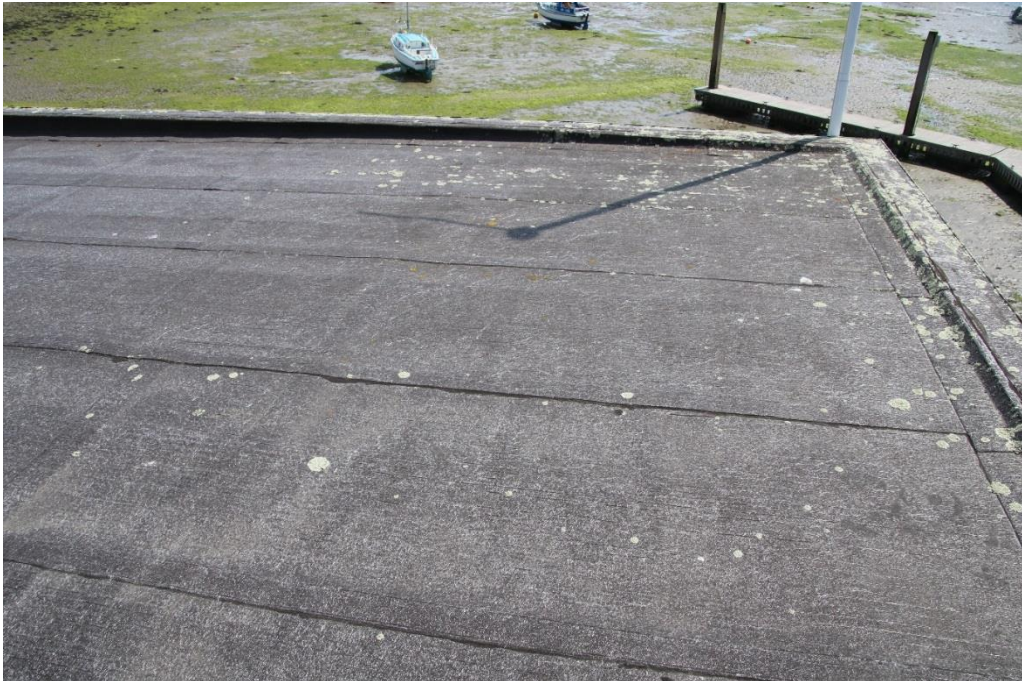
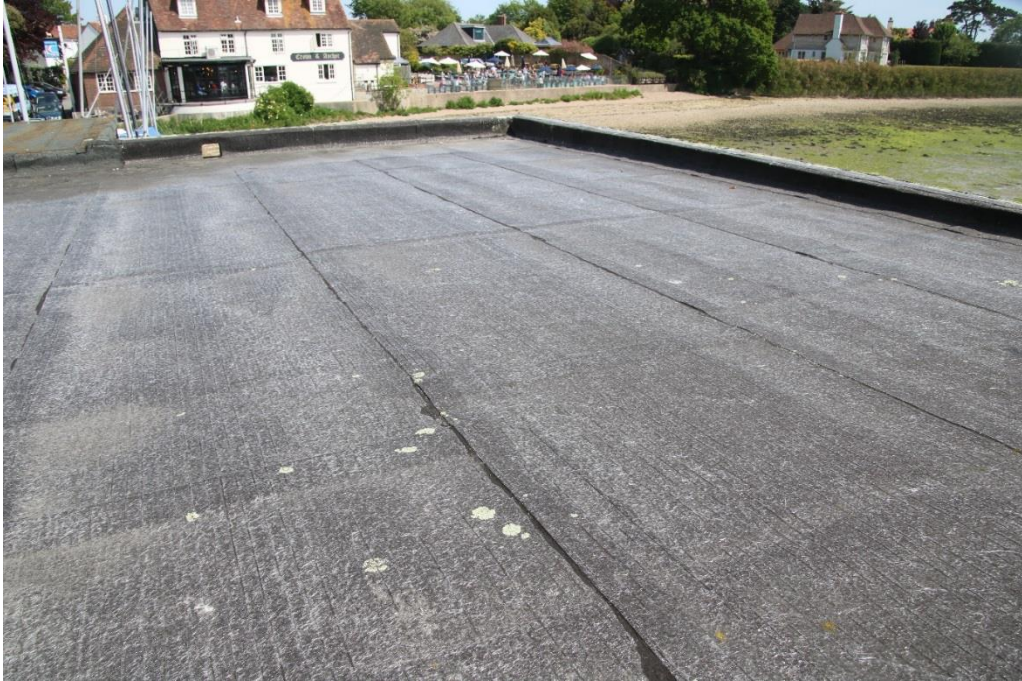
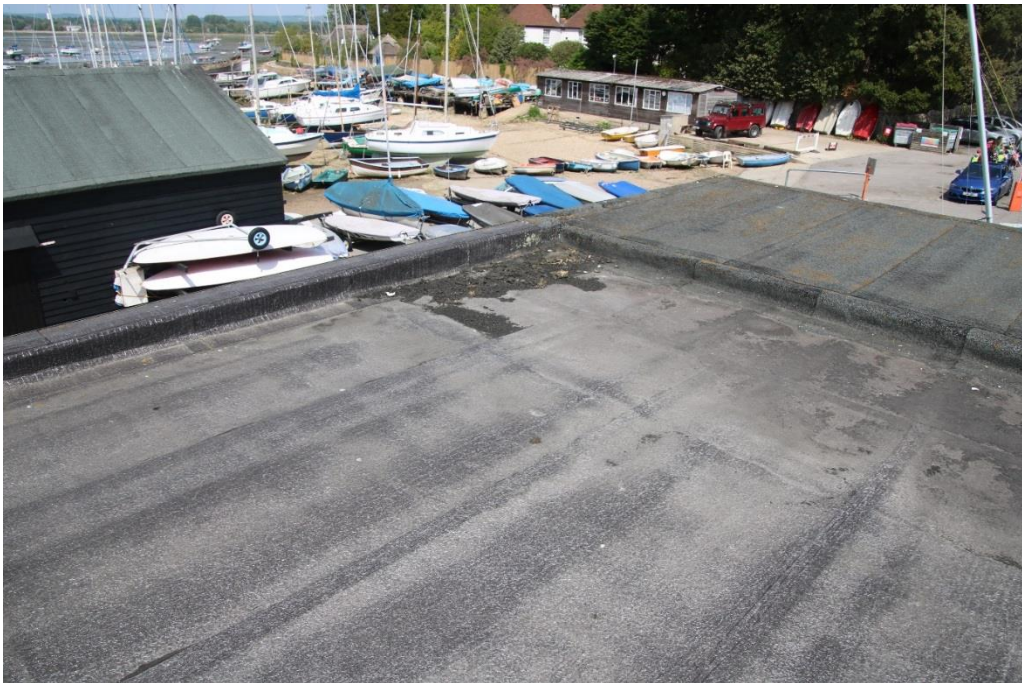
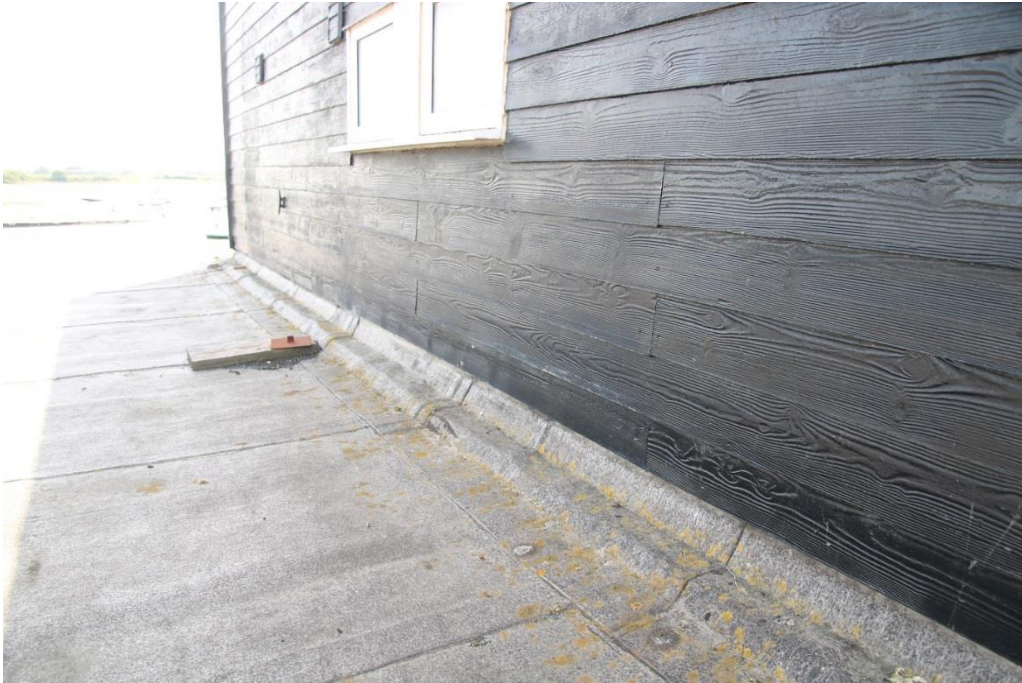
| Component | Location | Comment | Rating | Photo | Cost £ |
|---|---|--|---|---|---|
| Flat roof | Single storey club room, kitchen and store area | <p>Built-up felt roofing of similar material to the first floor flat roofing. In view of the age of the flat roofing material further investigations were carried out and a core sample taken to determine the condition of the felt roofing and the substrate beneath the flat roof membrane. This showed that the insulation levels are poor. This will result in high running costs.</p> <p>However, at the time of the survey there was no major evidence of recent or past water penetration from the flat roof. Flat roofs of this age have a limited expectancy and it is recommended that consideration should be given to replacing the flat roof membrane and improving the insulation levels in the near future. As can be seen from the photographs accompanying this report there are areas of ponding and associated moss growth to the north-east corner of the roof where the shallow pitched flat roof over the kitchen and store area meets the main roof. Ponding is an indication of possible future problems with the flat roof membrane material because the thermal movement at the edges of the pond due to evaporation can cause stresses in the felt flat roof membrane leading to tears and eventual failure.</p> | 2 | 4 - 7 | Included in cost above |

| Component | Location | Comment | Rating | Photo | Cost £ |
|---|--|--|---|---|---|
| | | When the flat roof membrane and associated boarding is renewed it is recommended that where there are currently areas of ponding the slopes of the roof should be amended or new rainwater outlets be installed so as to reduce the areas of ponding. | | | |

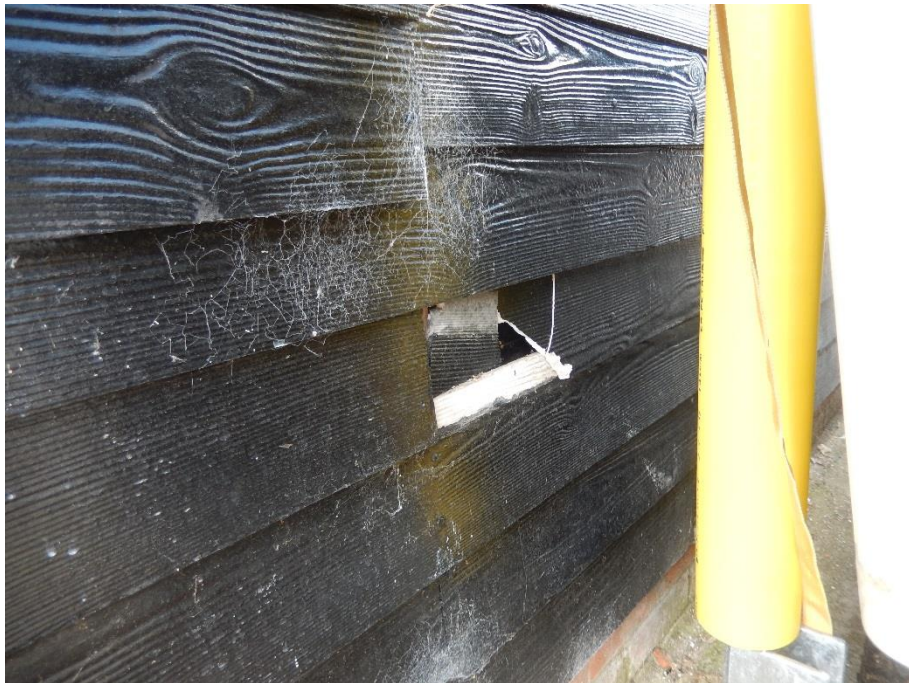
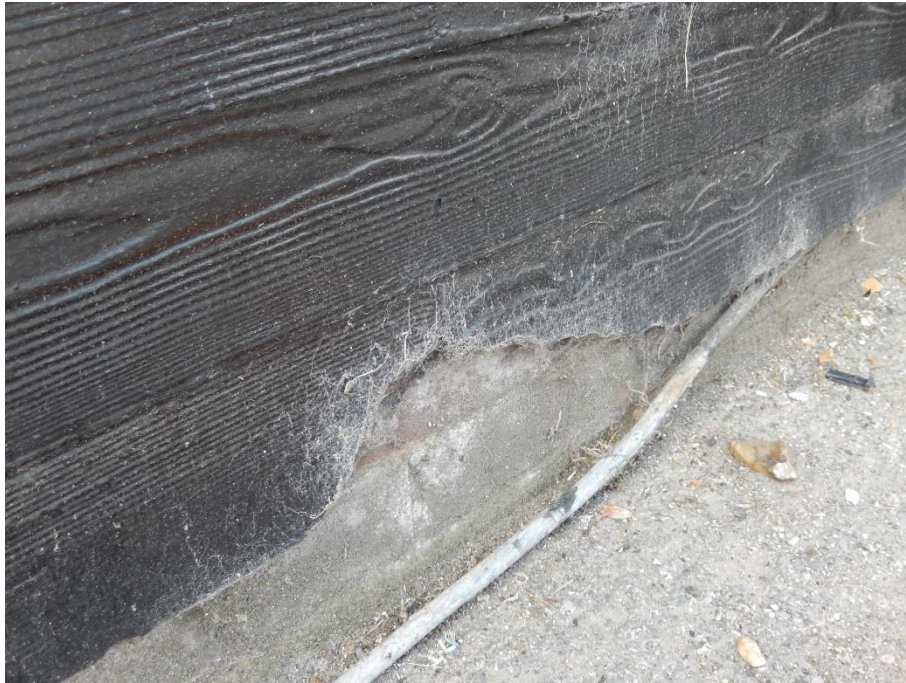
| Component | Location | Comment | Rating | Photo | Cost £ |
|---|--|--|---|---|---|
| External Wall Cladding | First floor changing rooms and ground floor club room, kitchen and kitchen store | <p>The construction in these areas is assumed to be blockwork single skin with an external timber frame fitted and composite shiplap cladding and timber boarding. The timber boarding has a gloss paint finish.</p> <p>The composite boarding does not have paint finish and is self-finished and the ongoing maintenance requirement for these areas is merely pressure jet washing to remove any staining and algae growth. That said, the quality of this older material is inferior to the range of composite cement boarding now widely available which is considered more substantial and durable. As such, in the longer term, the composite cladding will tend to require replacement but sound at present albeit with minor repairs required where mechanical damage has occurred.</p> | | 8 & 9 | |

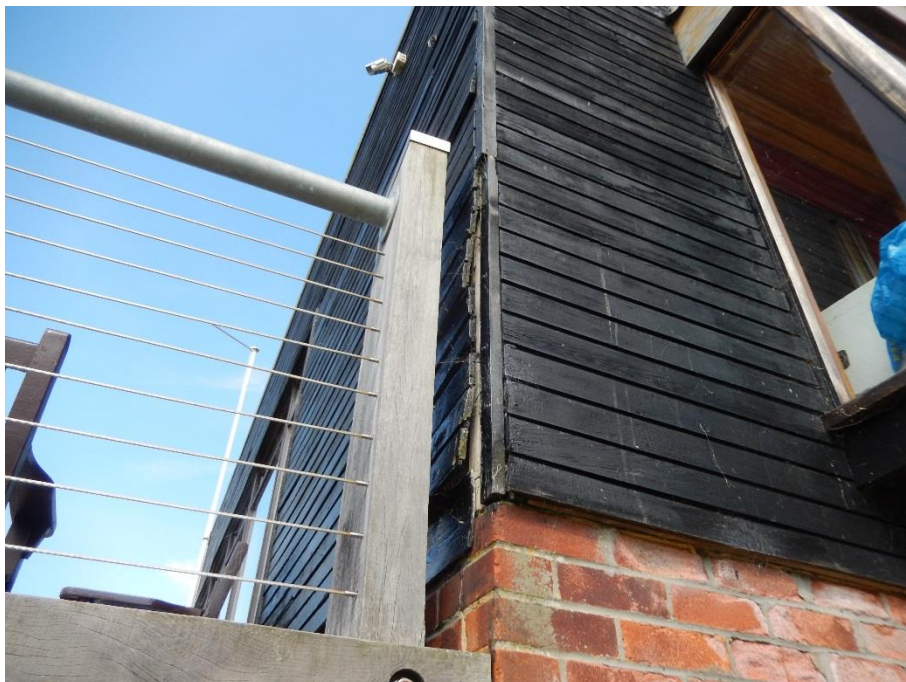
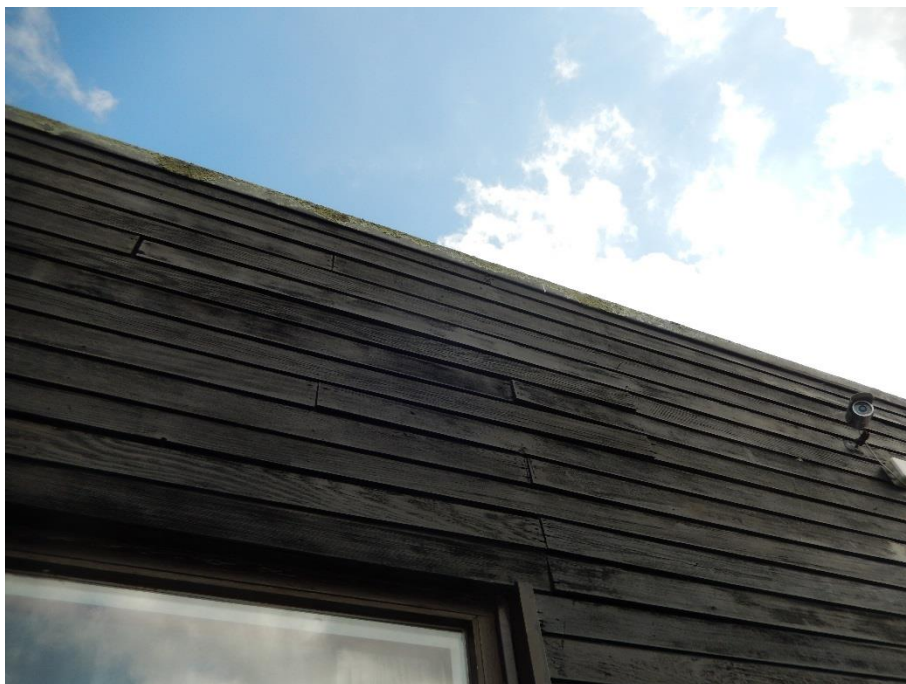
| Component | Location | Comment | Rating | Photo | Cost £ |
|---|--|---|---|---|---|
| | | <p>Timber cladding is retained to the three walls of the club room extension over the water. This is substantially sound but defective to the south-east corner and warping in some areas.</p> <p>The clear preference would be to replace this cladding in conjunction with replacement of windows to the south and west elevations and redecoration of the oriel window to the eastern elevation.</p> | 2 | 10 & 11 | 5,000 |

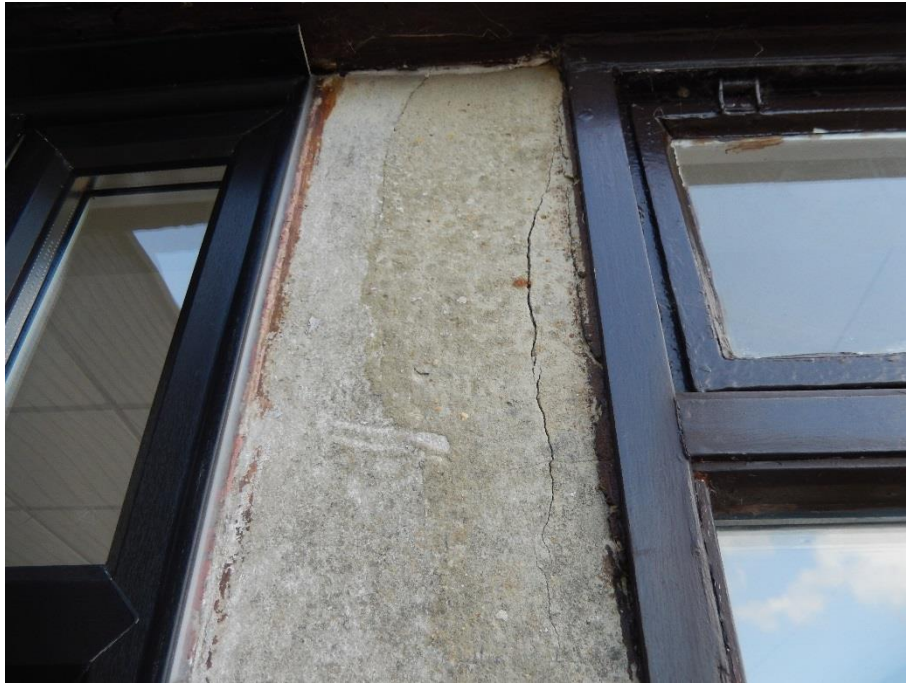
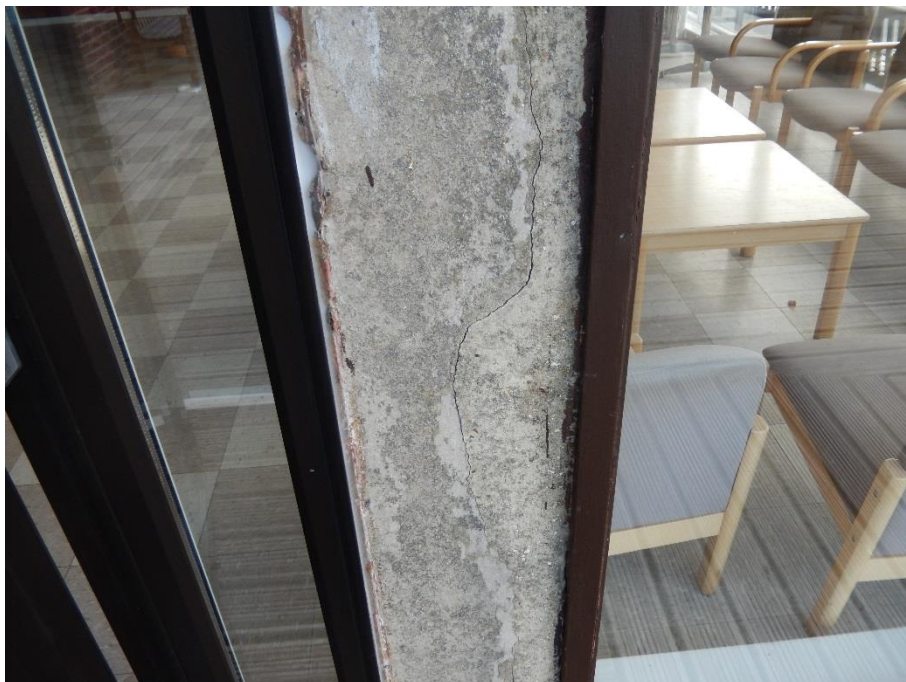
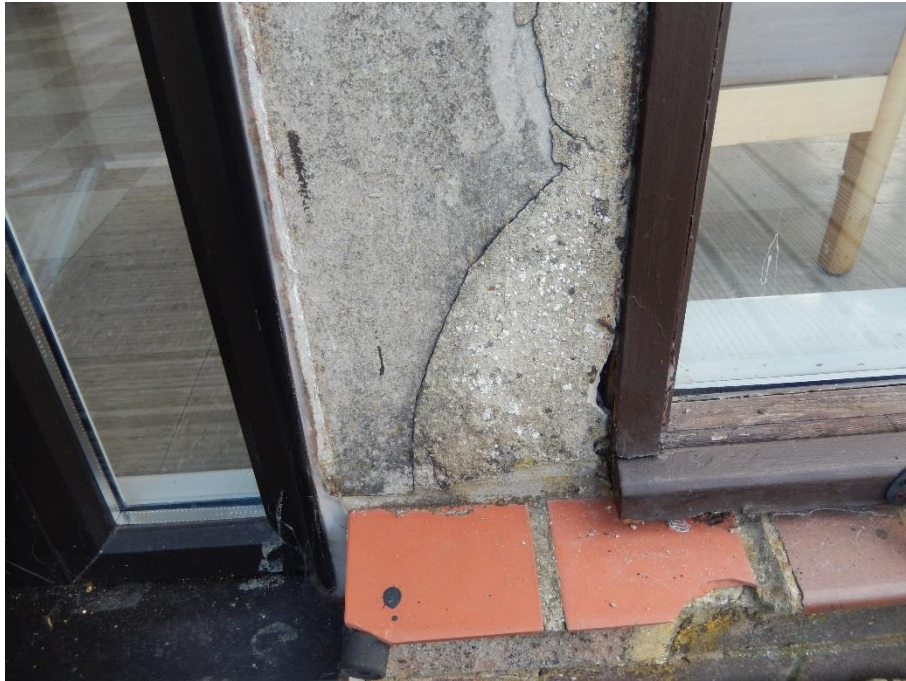
| Component | Location | Comment | Rating | Photo | Cost £ |
|---|--|---|---|---|---|
| | Western elevation of extension | <p>Minor brick repairs required at low level to north-west corner.</p> <p>In addition, there are two exposed concrete columns, one to the south-west corner. Some minor fracturing is evident caused it is assumed by water ingress in turn causing buried steel reinforcement or steel stanchions beginning to corrode and expand. These columns are in compression so there are no concerns as to structural adequacy. However, it is very important that this deterioration is stopped and simply achieved by capping in PVC in conjunction with replacement of windows.</p> | 1 | 13, 14 & 15 | Included with windows |

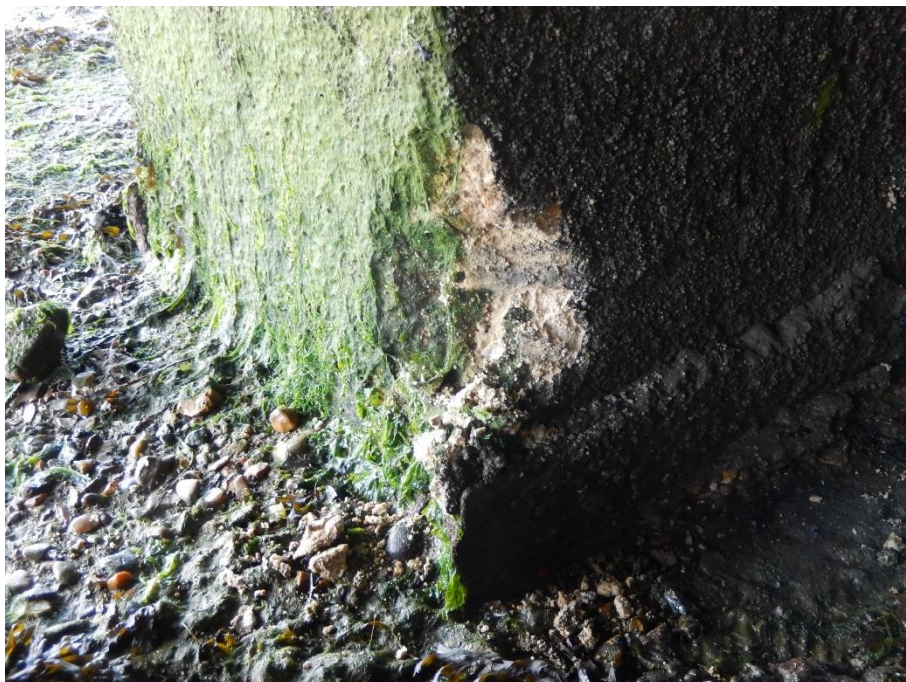
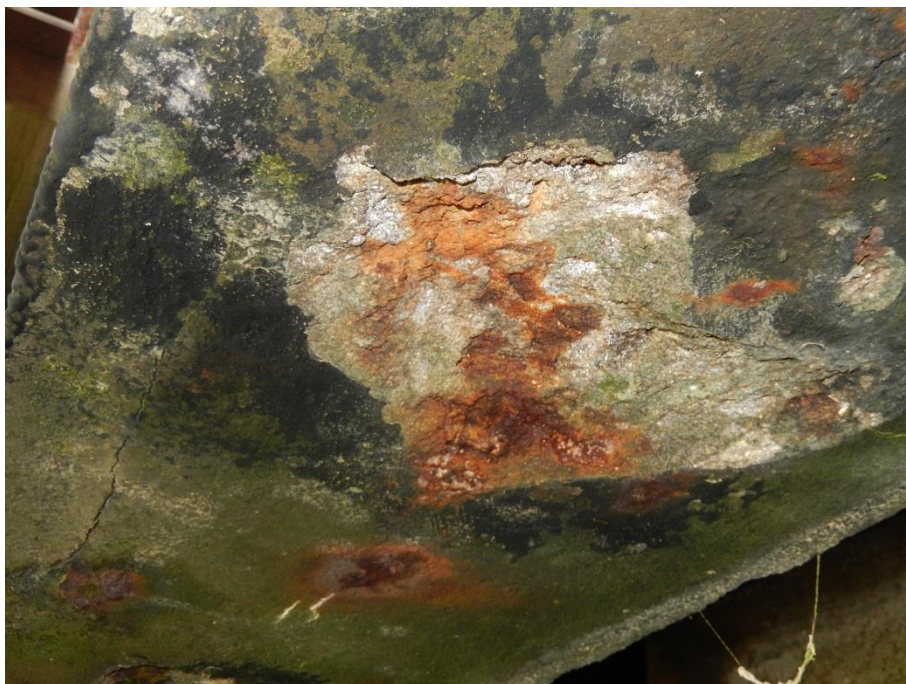
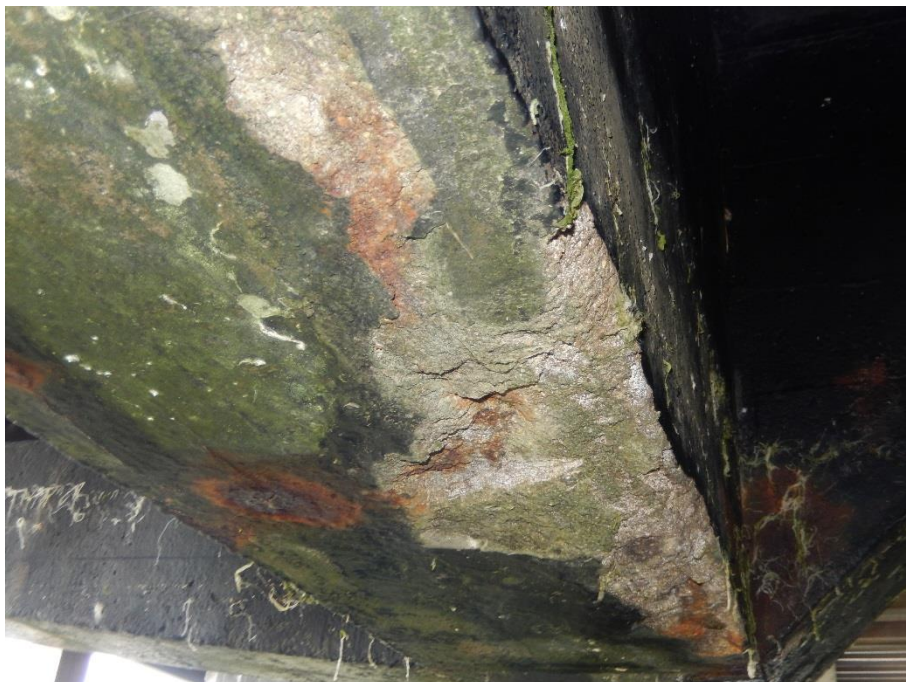
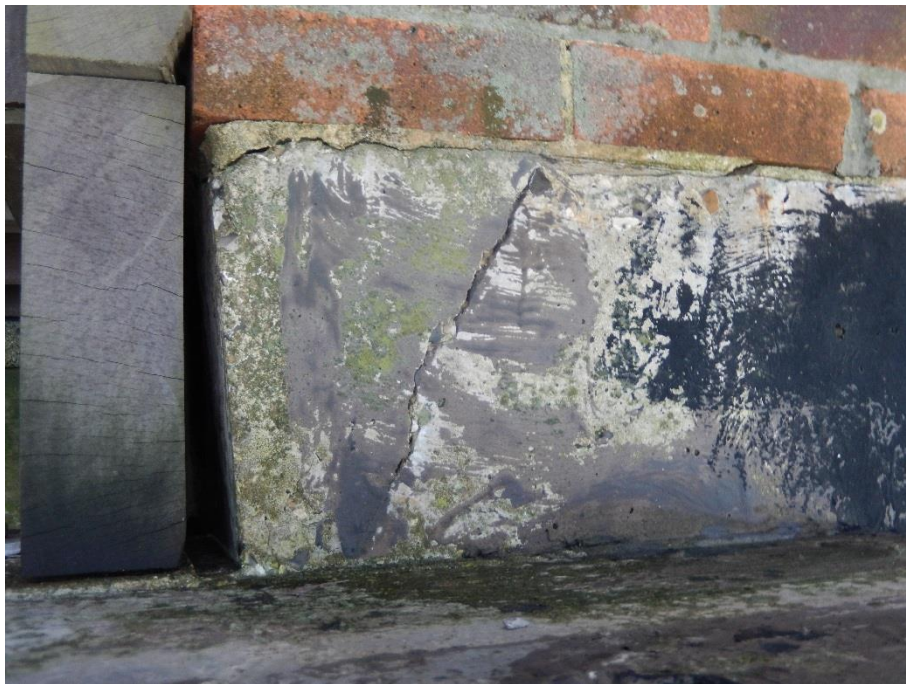
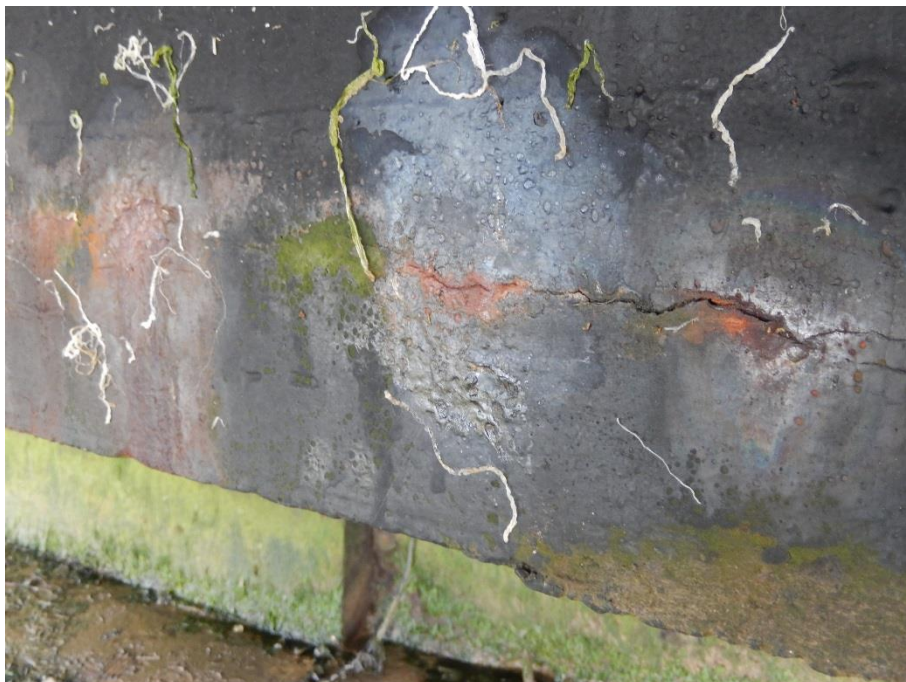
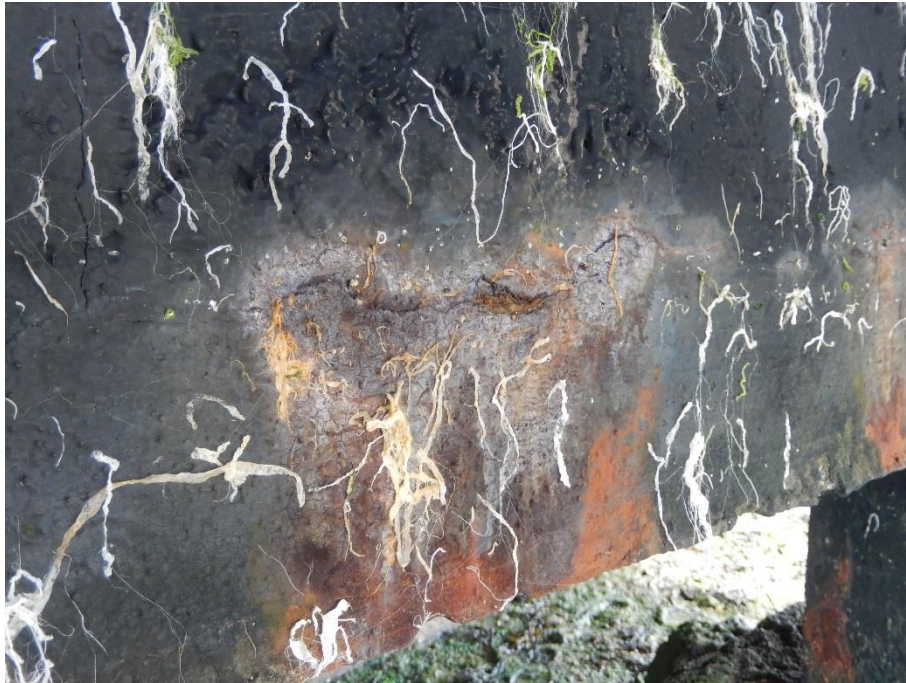
The Cantilevered Structure: This is of cast in situ reinforced concrete construction comprising a slab with deep downstand beams and supported on two columns on concrete pad foundations. The majority of this structure is at or below the water line at high tide.

There are some concerns with the concrete cover to reinforcement in some areas with further advice from a Structural Engineer required followed by some form of epoxy or similar repairs. Undertaken at this relatively early stage should involve only quite modest costs.

If left untreated the rate of deterioration would accelerate leading to high repair costs. As such this is a high priority issue.

| Component | Location | Comment | Rating | Photo | Cost £ |
|---|--|--|---|---|---|
| Concrete sub-structure | Underside of club room extension | Further advice required as to how best to repair damaged areas to retard deterioration. There are specialist concrete repair companies who will undertake reports free of charge but repair costs may well be disproportionately high. It is therefore recommended that a Structural Engineer (such as Peter Wilmott at Archibald Shaw) be engaged to advise and supervise these repairs. | 1 | 16-21 | 5,000 |

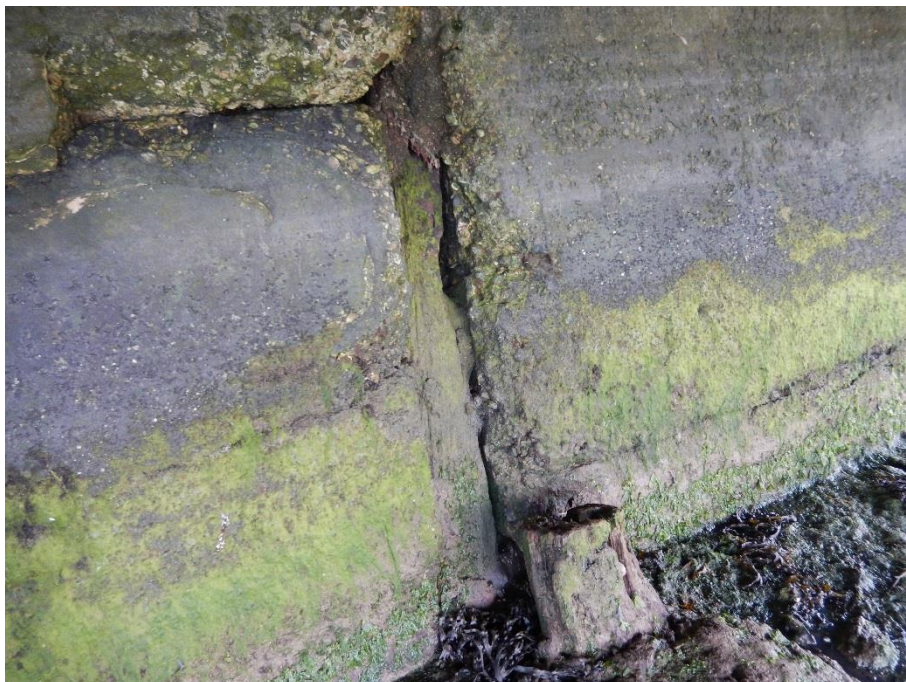
| Component | Location | Comment | Rating | Photo | Cost £ |
|---|--|--|---|---|---|
| Sea wall | Western side | Weak in one particular area where an old timber is exposed but this wall is not your repairing liability. | | 22 | |

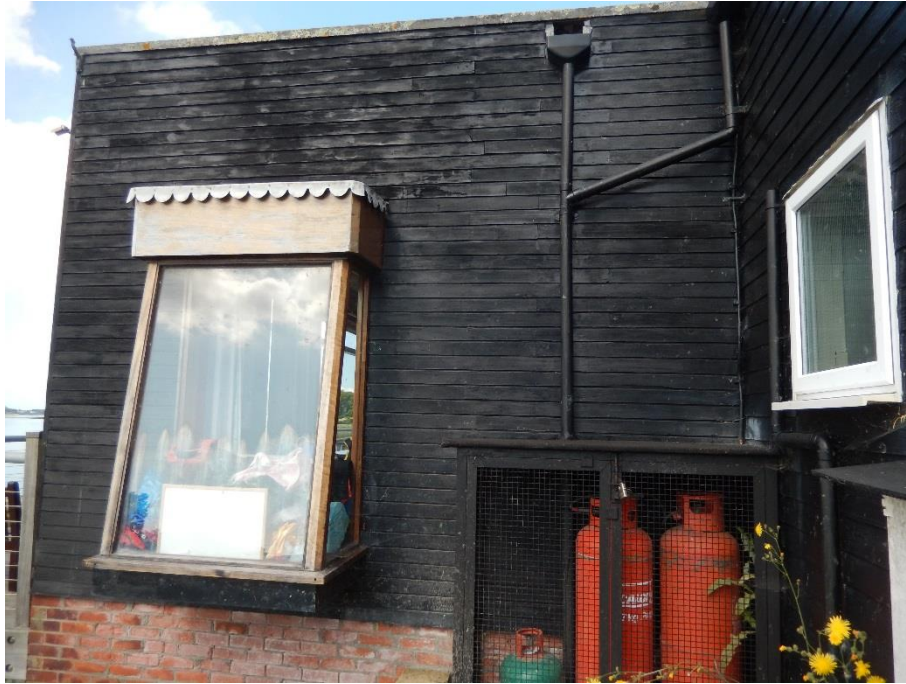
| Component | Location | Comment | Rating | Photo | Cost £ |
|---|---|---|---|---|---|
| Timber external windows | Ground floor club house | To the east facing elevation to the main club lounge there is a varnished finish feature window which is single glazed. Given the fact that it is single glazed and requires decoration it is recommended that consideration should be given to replacing this with a UPVC double glazed unit. For the time being however re-varnishing or stripping and staining will extend the life of this window but access for maintenance is difficult which will increase the cost of repairs | 2 | 23 | 750 |

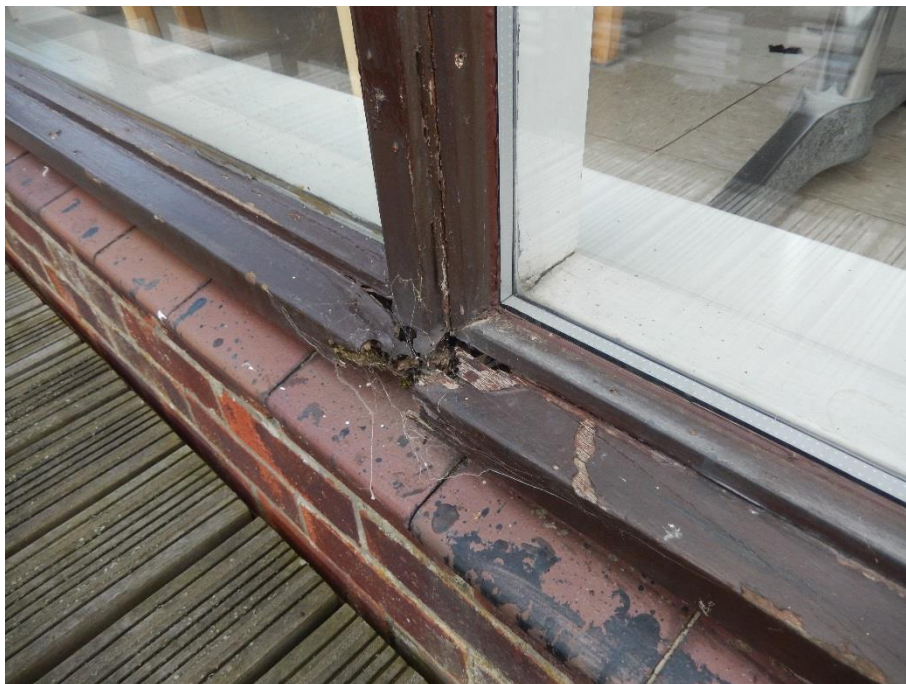
| Component | Location | Comment | Rating | Photo | Cost £ |
|---|---|--|---|---|---|
| | | <p>To the south facing elevation to the main club lounge there is a substantial picture window. This is timber framed construction. There are large panes of double glazed windows. Severe rot evident in part at cill level.</p> <p>Above the fixed glass screens there are top hung opening lights. These are single glazed Crittall steel windows. The timber frame is stained. There are a number of areas where the tiled cill beneath the timber windows and UPVC windows require minor repair.</p> <p>In view of the single glazed top hung Crittall steel windows and the configuration of the glazed screen, it is recommended that these be replaced with UPVC double glazed units. This has the advantage of reducing the future decoration liability of the building. It would also enable the windows to have a pattern that enabled internal ventilation of the property to be easily undertaken and improved.</p> | 2 | 24 | 5,000 |

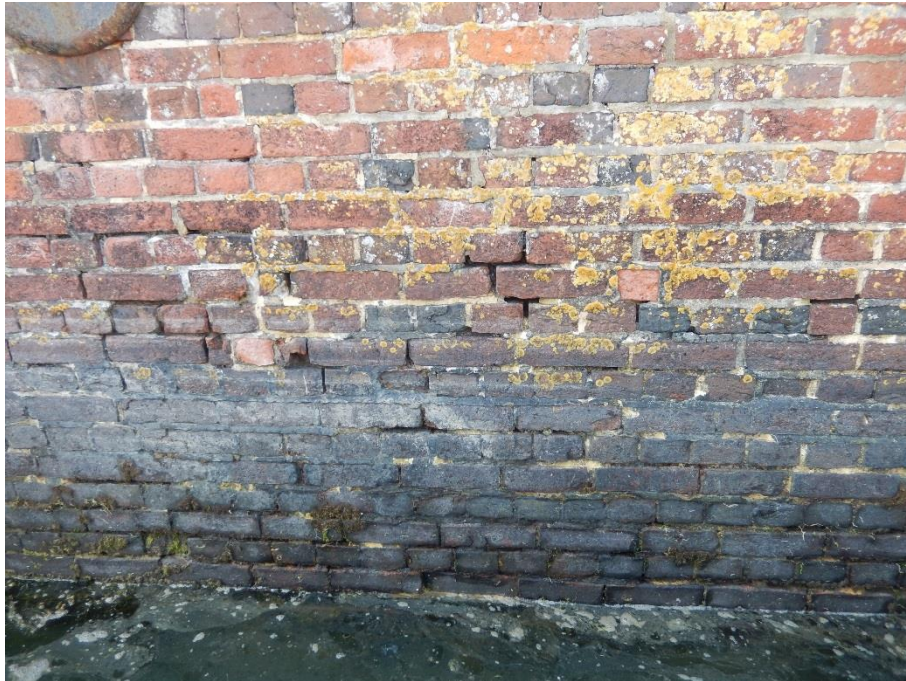
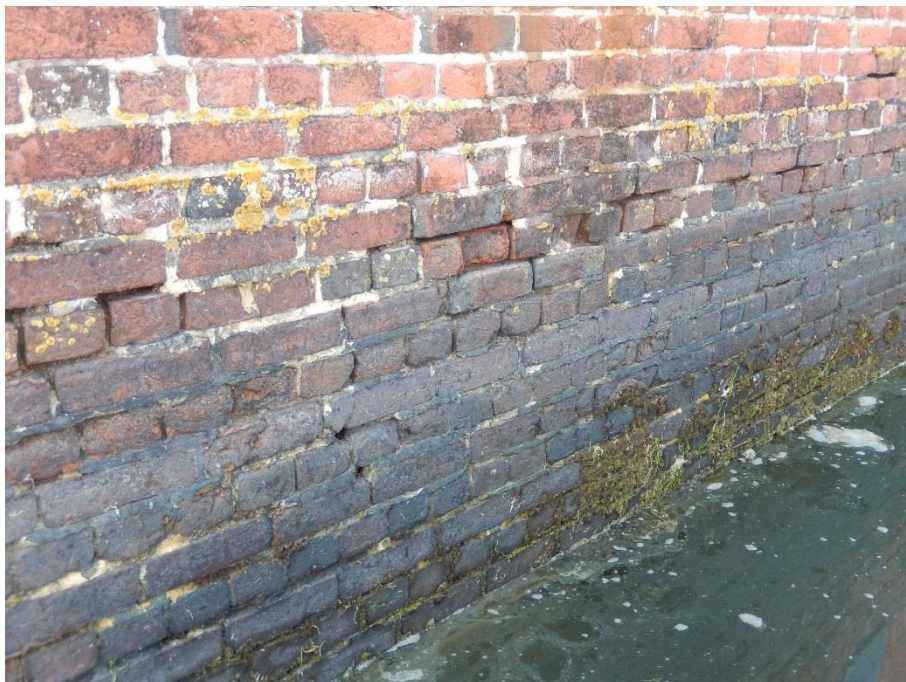
| Component | Location | Comment | Rating | Photo | Cost £ |
|---|---|--|---|---|---|
| | North elevation | Below ground level this is classified as being the sea wall and not your repairing liability but in need of repair/re-pointing. | | 25 & 26 | |

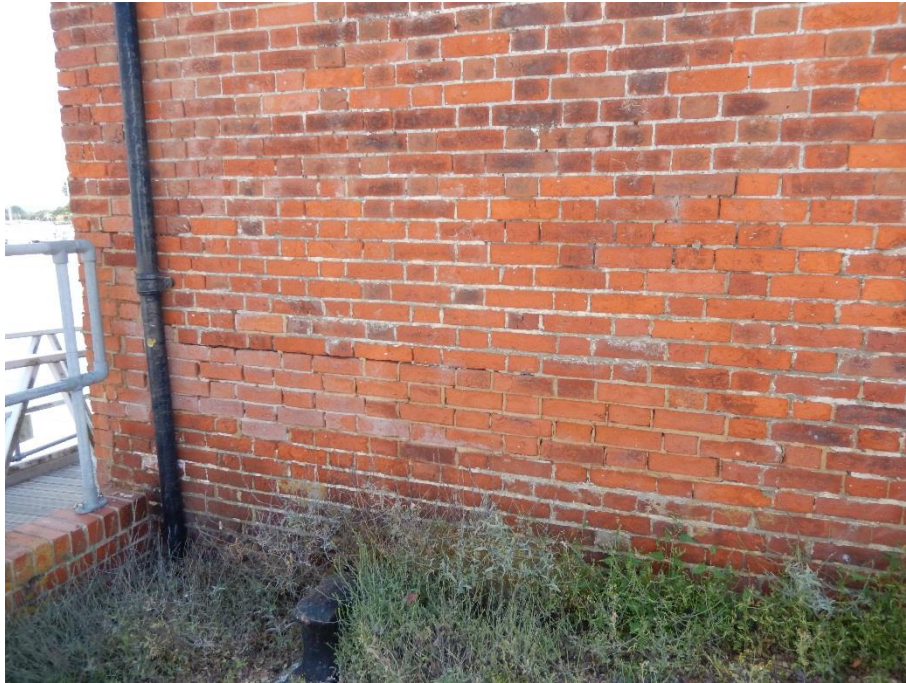
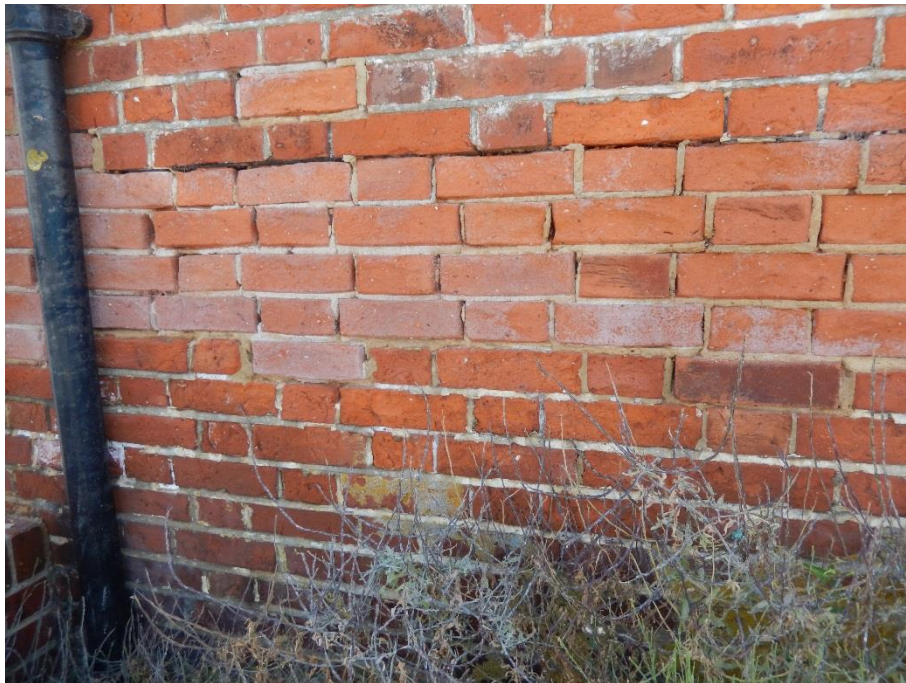
| | West elevation | Isolated repairs and re-pointing required. | 2 | 29 & 30 | 1,000 |

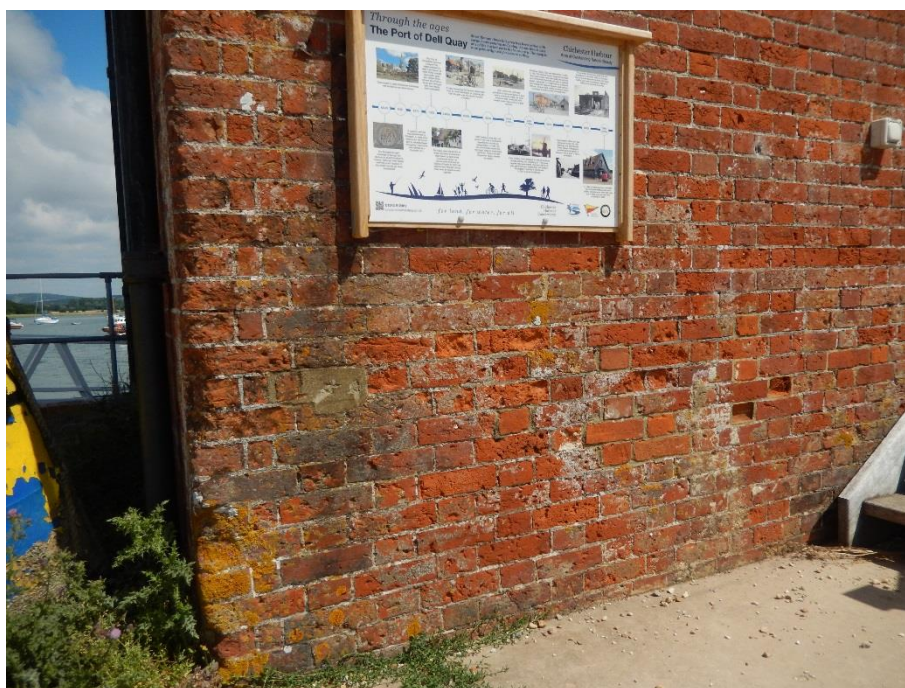
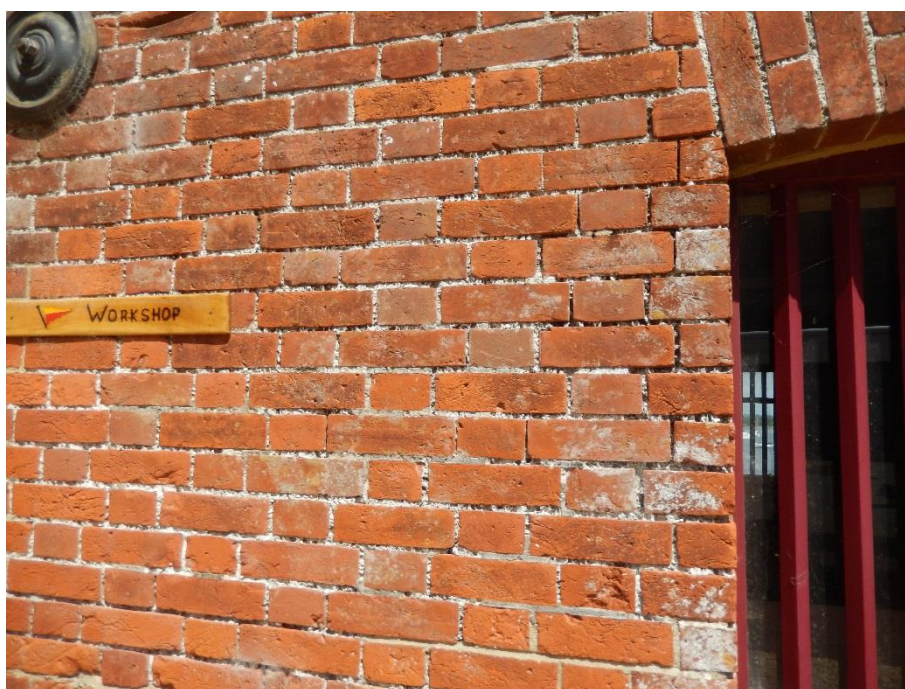
| | South elevation | Attractive but with several areas of badly perished bricks and pointing with quite extensive areas of cutting out and replacement required. Patch re-pointing would severely affect the appearance with full re-pointing recommended. | 2 | 31 & 32 | 6,000 |

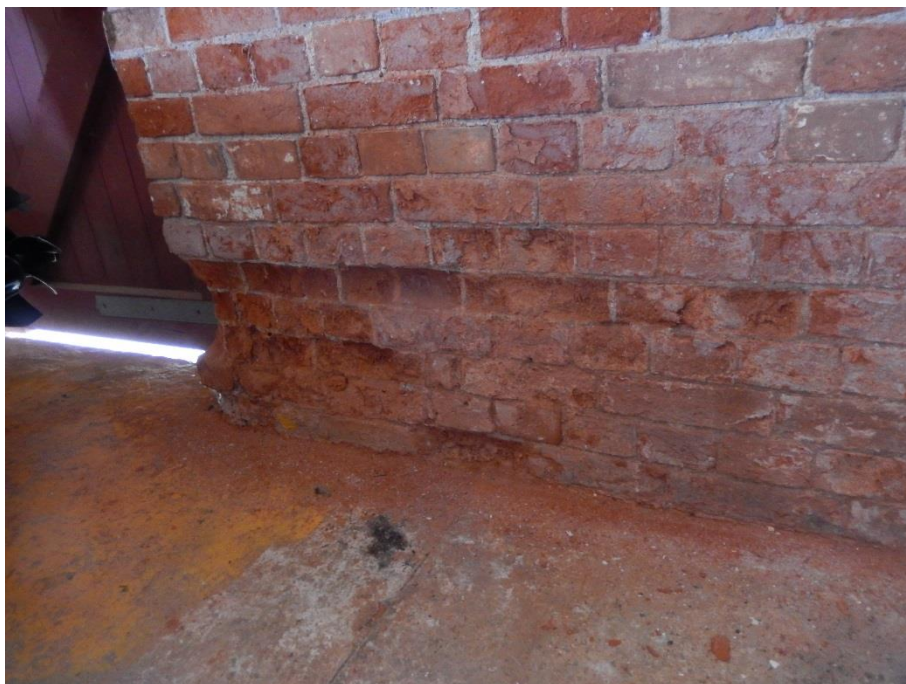
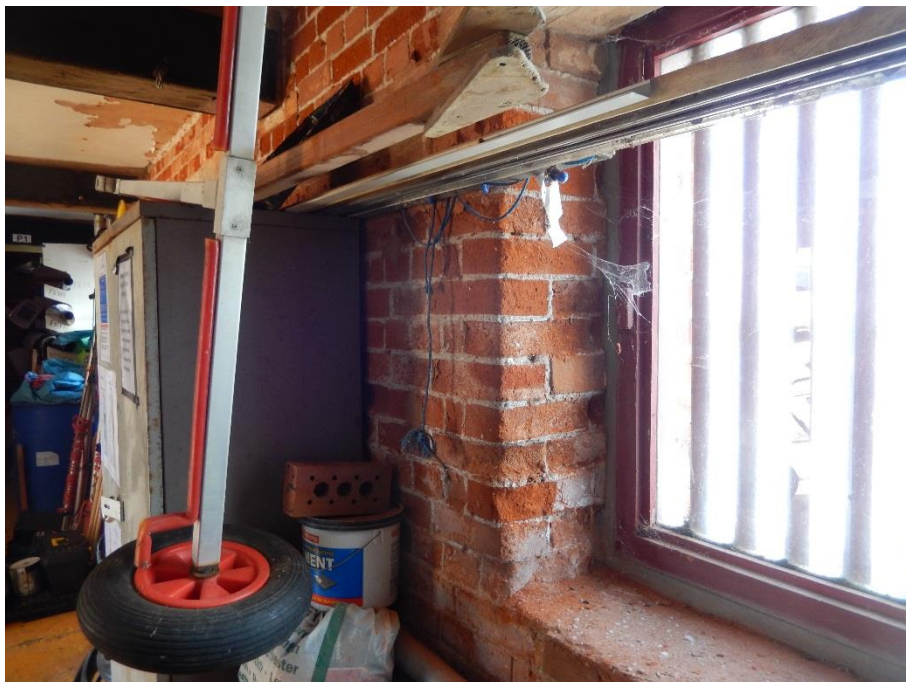
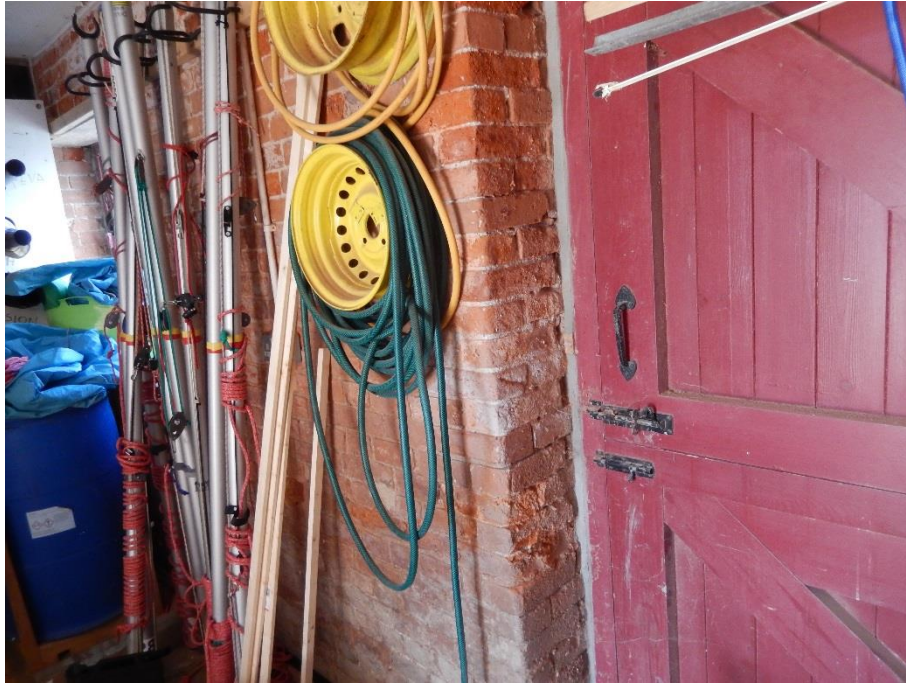
| | Ground Floor store and workshop area | <p>The ceiling was plasterboard assumed on intermediate joists between the main floor beams. The floor beams were finished timber beams with metal fixed to the side of the timber beams to improve their load bearing capacity.</p> <p>The walls are exposed brickwork. It was noted that there are some areas where repairs are required to the brickwork. The windows and doors are timber and these require decorations in two years but were in reasonable condition.</p> <p>The floor is solid concrete and a limited inspection of the floor was undertaken due to the considerable storage of materials within the area however where seen appeared in good condition.</p> | <p>3</p> <p>2</p> <p>3</p> | 33, 34 & 35 | |
