Roof Survey Report

Dell Quay Sailing Club
Dell Quay Road, CHICHESTER
PO20 7EE, England

30th May 2019
Project Reference: B192015/1

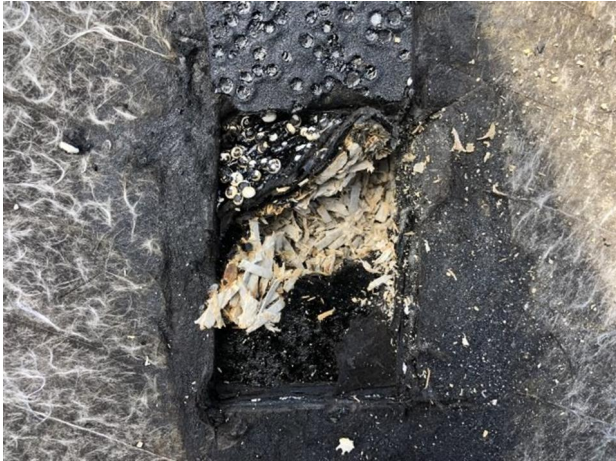
Core sample 1 showing woodwool deck.

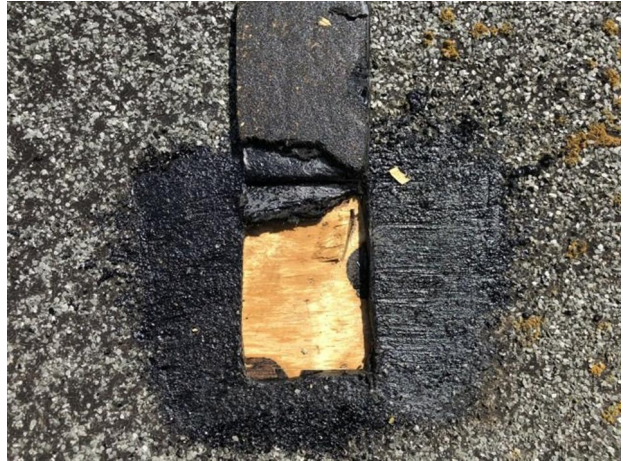
Core sample 2 showing plywood deck.

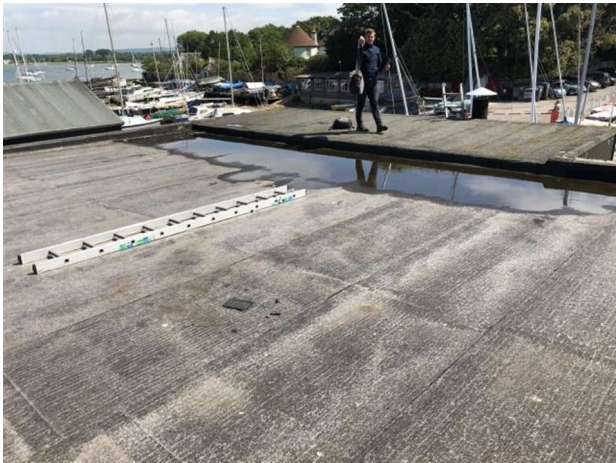
Overview of Roof A.

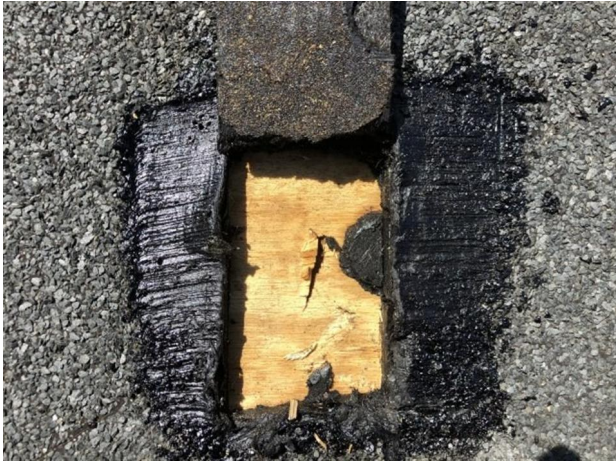
Core sample taken on Roof B.

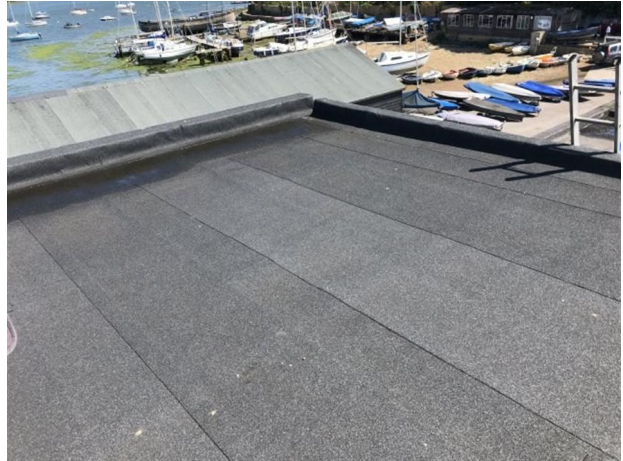
Overview of Roof B.

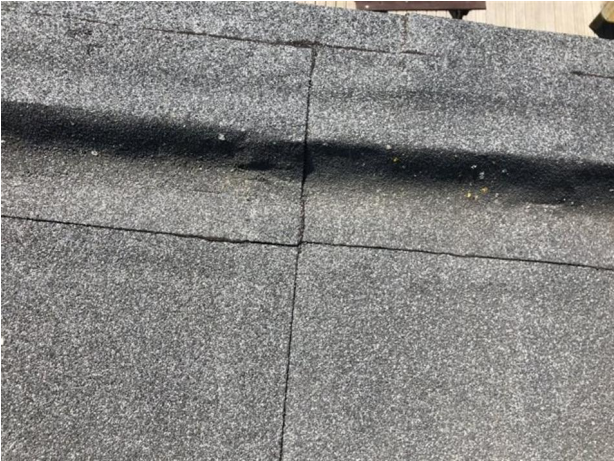
Installation of membrane is incorrect and laps should be staggered, this is a clear weakness which could lead to issues.

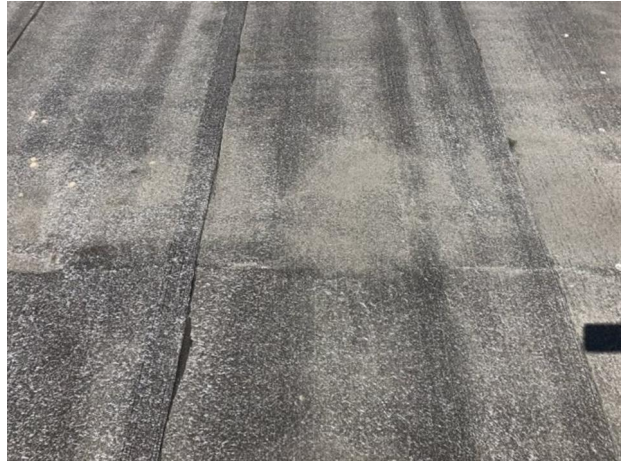
Membrane has lost all of its mineral and its at the end of its serviceable life.

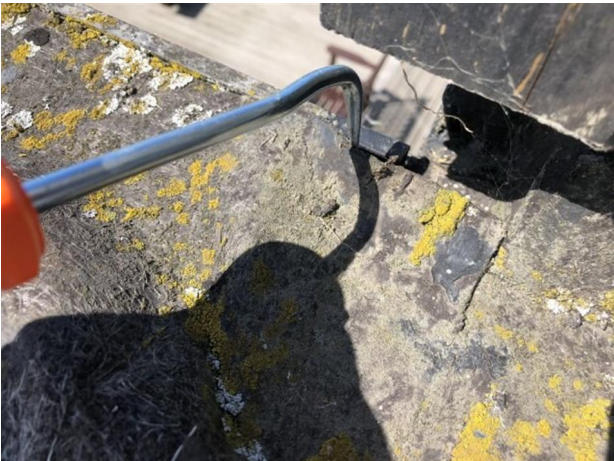
Laps are beginning to fail.

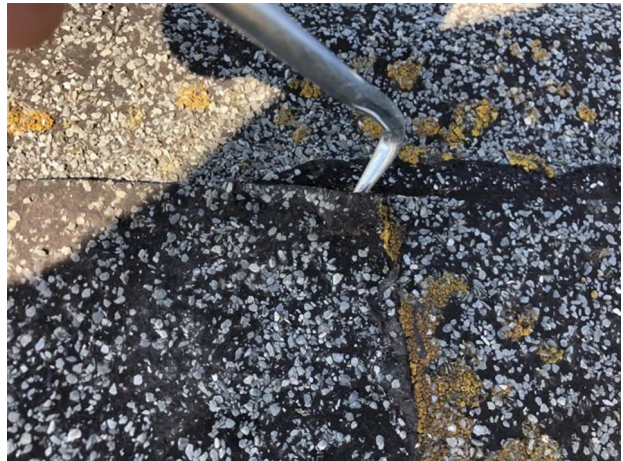
Further lap issues.

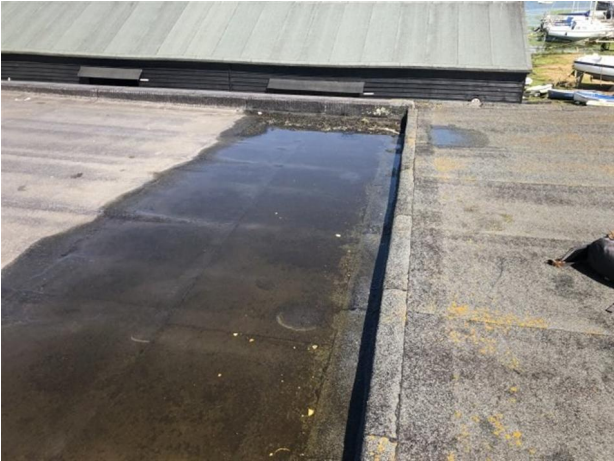
The roof has been designed to drain to the internal channels. However, standing water collects within the gutter due to a lack of adequate cross-falls. These falls should be improved within the new roof design.

There is a lot ponding in a small section of the roof due to a lack of cross falls, this will be rectified by installing a tapered gutter.

- To alleviate standing water within the existing gutter channels, tapered insulation has been included with our waterproofing system proposal specifically for these locations.

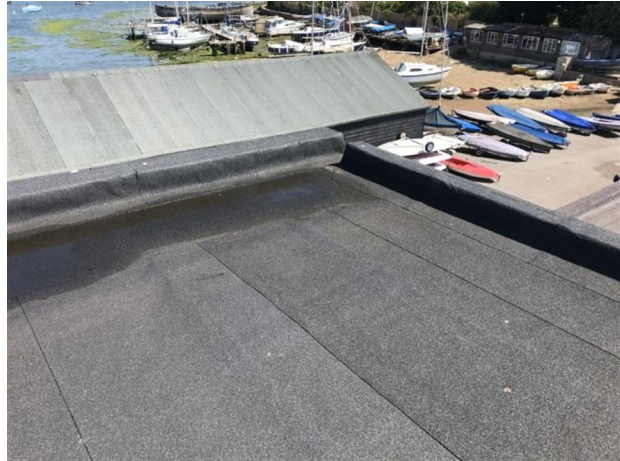
Ponding on Roof B due to a lack of cross falls and a build up of membranes at the outlet.

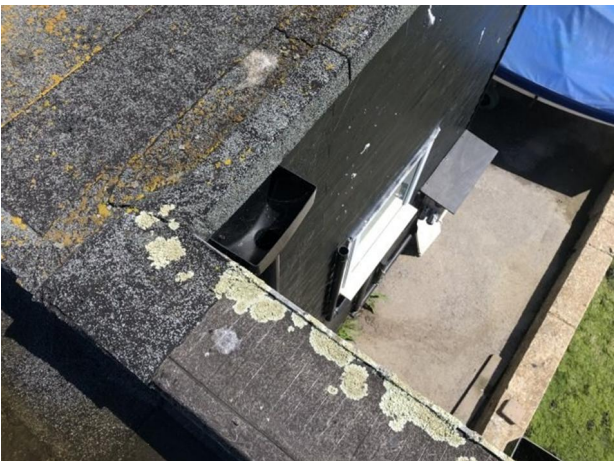
We noted that the existing lead chutes are aged, defective and generally in poor condition. These are considered unfit for reuse and should be replaced as part of the re-waterproofing works.

Outlet has been blocked off, new lead chute to be installed to hopper.

- The existing drainage chutes are to be removed and new site fabricated lead replacement items installed.
- Provision should be made for temporarily removing the cladding to allow working access to raise and waterproof the abutment upstands. Allowance is to be made for trimming the cladding and modifying the position of the lower fixing rails and/or metal drip flashing where required.

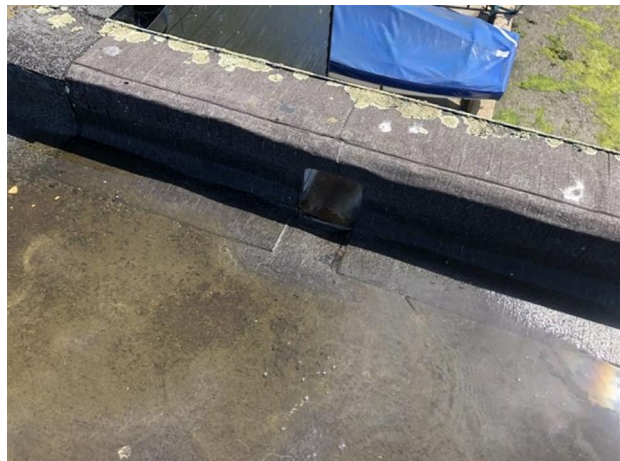
Build up of laps has created an issue at the chute. This will be rectified with the new system.

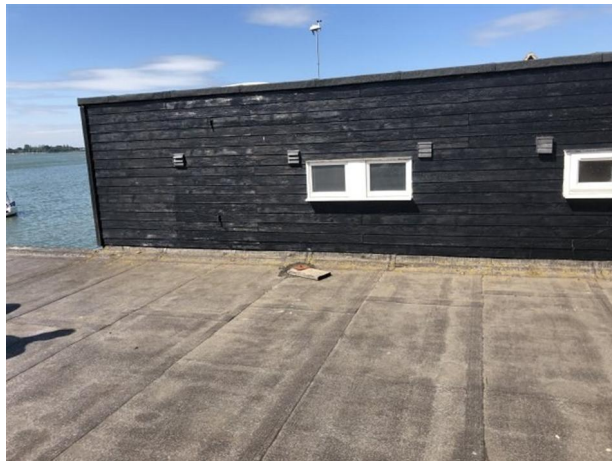
The existing cladding obstructs access to re-waterproof the upstand. It will therefore be necessary to remove the cladding to enable the roofing works to be undertaken. Upon completion the cladding can be reinstated allowing for any modification that maybe required.

Cladding will need to be altered to create a 150mm upstand.

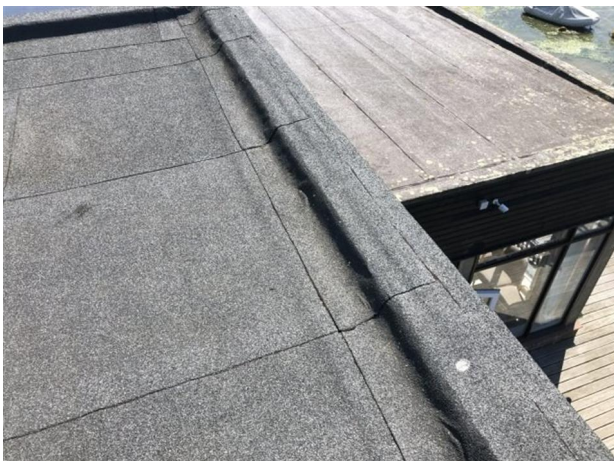
When the waterproofing is refurbished the perimeter check kerbs will not provide a 50mm upstand above the finished roof level. As a consequence the perimeter kerb will require raising.

Check kerbs will need to be raised.

- The height of existing perimeter check kerbs must be increased to provide a minimum 50mm upstand above the finished roof level. The perimeter is to be raised to one consistent level around the full roof area.

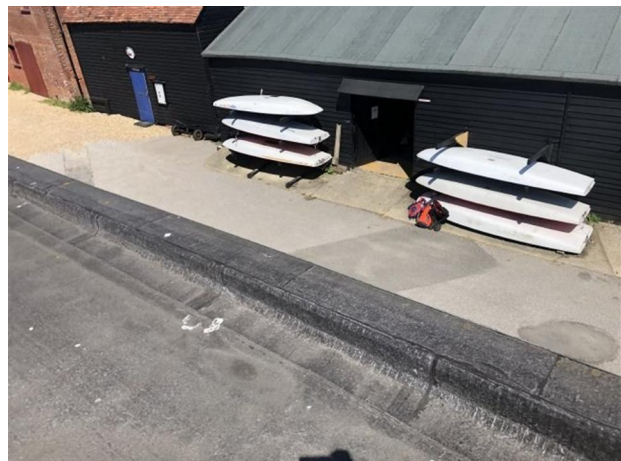
Kerb to be raised. With this a new fascia panel will need to be installed to the external facade.

- An additional depth of fascia board is to be installed to cover the new perimeter kerb. Alternatively the existing perimeter fascia boards could be renewed in their entirety. Any new fascia system to be installed to cover the perimeter kerb should be manufactured from a maintenance free material to offer a life expectancy that is at least comparable to the guarantee of the new waterproofing system. This avoids the risk of disturbing the waterproofing system or affecting the roof guarantee, should the existing fascia require replacing whilst the roof remains in-situ. Full details of the system and scope of works to the fascia boards is to be included within the main client specification/ schedule of works.

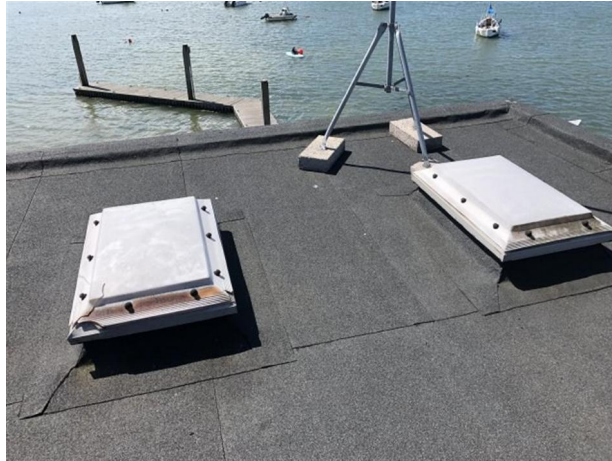
The existing rooflights mounted upon builders kerbs will need removing in order to allow the kerb height to be raised to the required minimum height and then re-waterproofed.

Rooflight kerbs will need to be raised.

- The existing rooflights must be removed to enable the upstand kerb to be raised to comply with the required minimum upstand height. Raising the kerbs will affect the internal linings and provision should be included for any consequential extension and re-decorating work to the linings.

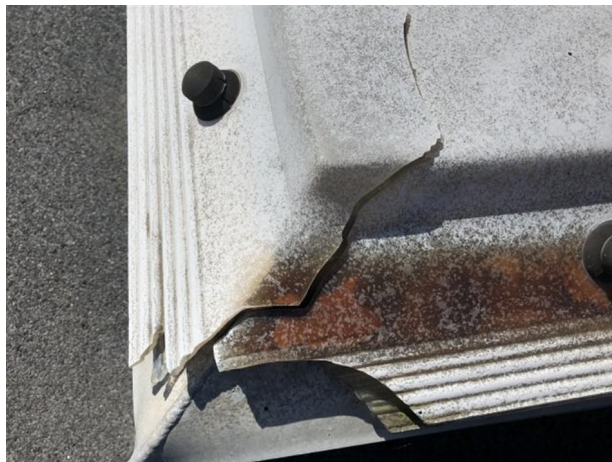
The current rooflights are proprietary plastic glazed units. These fall below current thermal and light transmittance standards and the performance will continue to decrease with age. The service life of these rooflights is not compatible with the service life of the new waterproofing system and for these reasons we propose that they are replaced. Please be aware that these units may contain asbestos in the internal linings.

Rooflights are in a poor condition and should be replaced.

- The existing rooflights should be replaced with new modular Bauder Rooflight units that offer improved thermal and light transmittance performance and are classified as being non-fragile. These will complement the performance of the replacement waterproofing system during its serviceable life. Please advise your requirements and we will include these within our separate schedule and specification for replacement Bauder Rooflights.
